Colored Concrete: Does it Deliver the Goods?

17th Annual TERRA Pavement Conference
February 14th, 2013

Tom Burnham, P.E.
Minnesota Department of Transportation

Investigation and Assessment of Colored Concrete Pavement

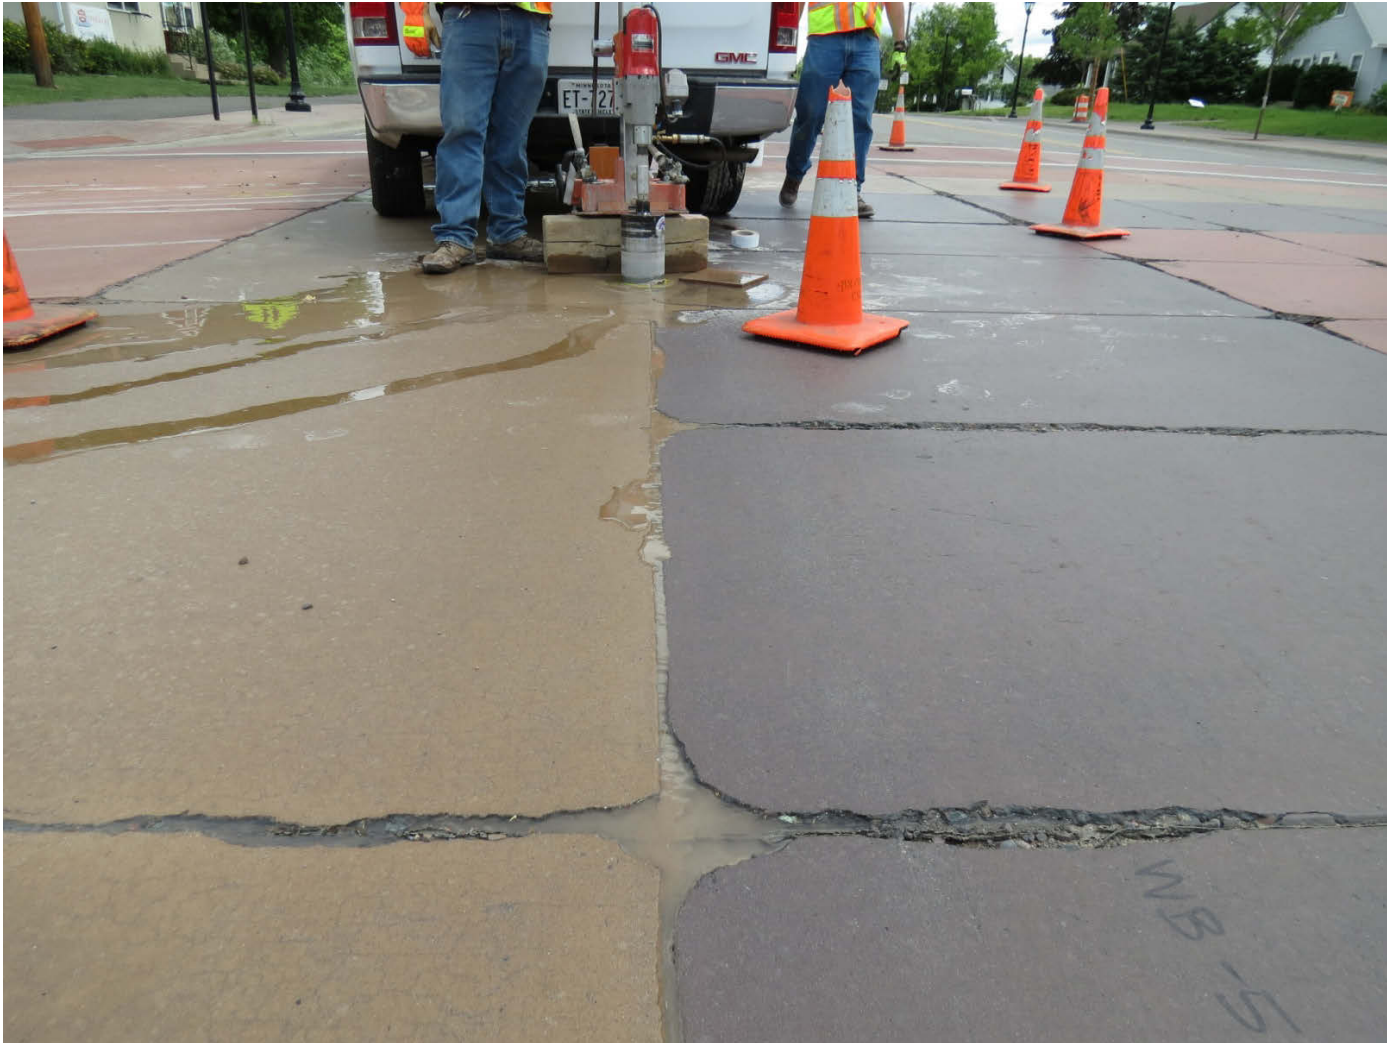
Cty Hwy 14, Main Street, Centerville

*And it's called:
Early Joint Distress*

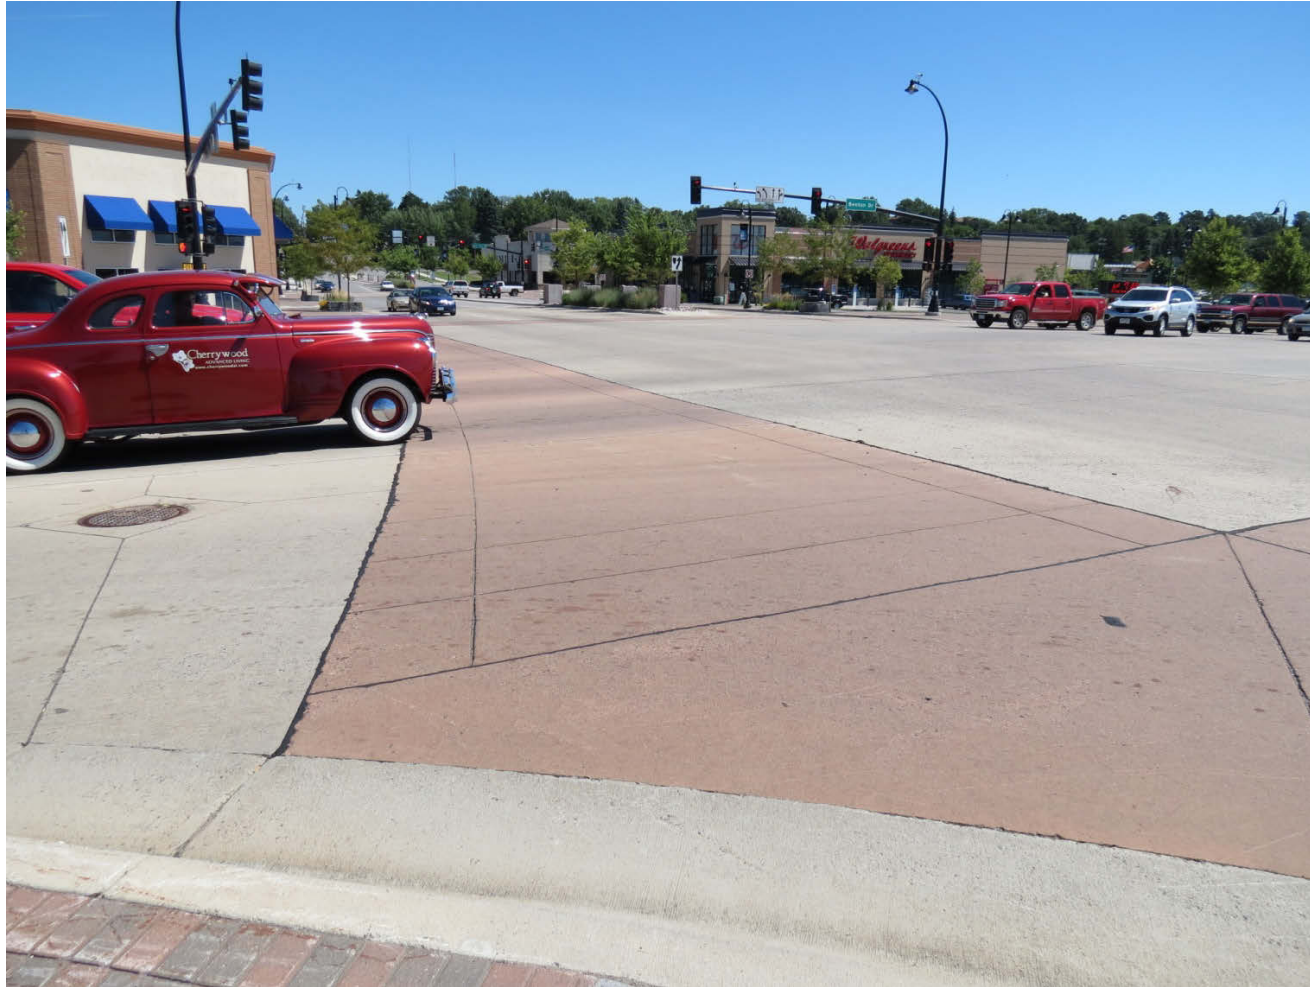
Benton Dr and 2nd St, Sauk Rapids (Built 2007)

Good Performance

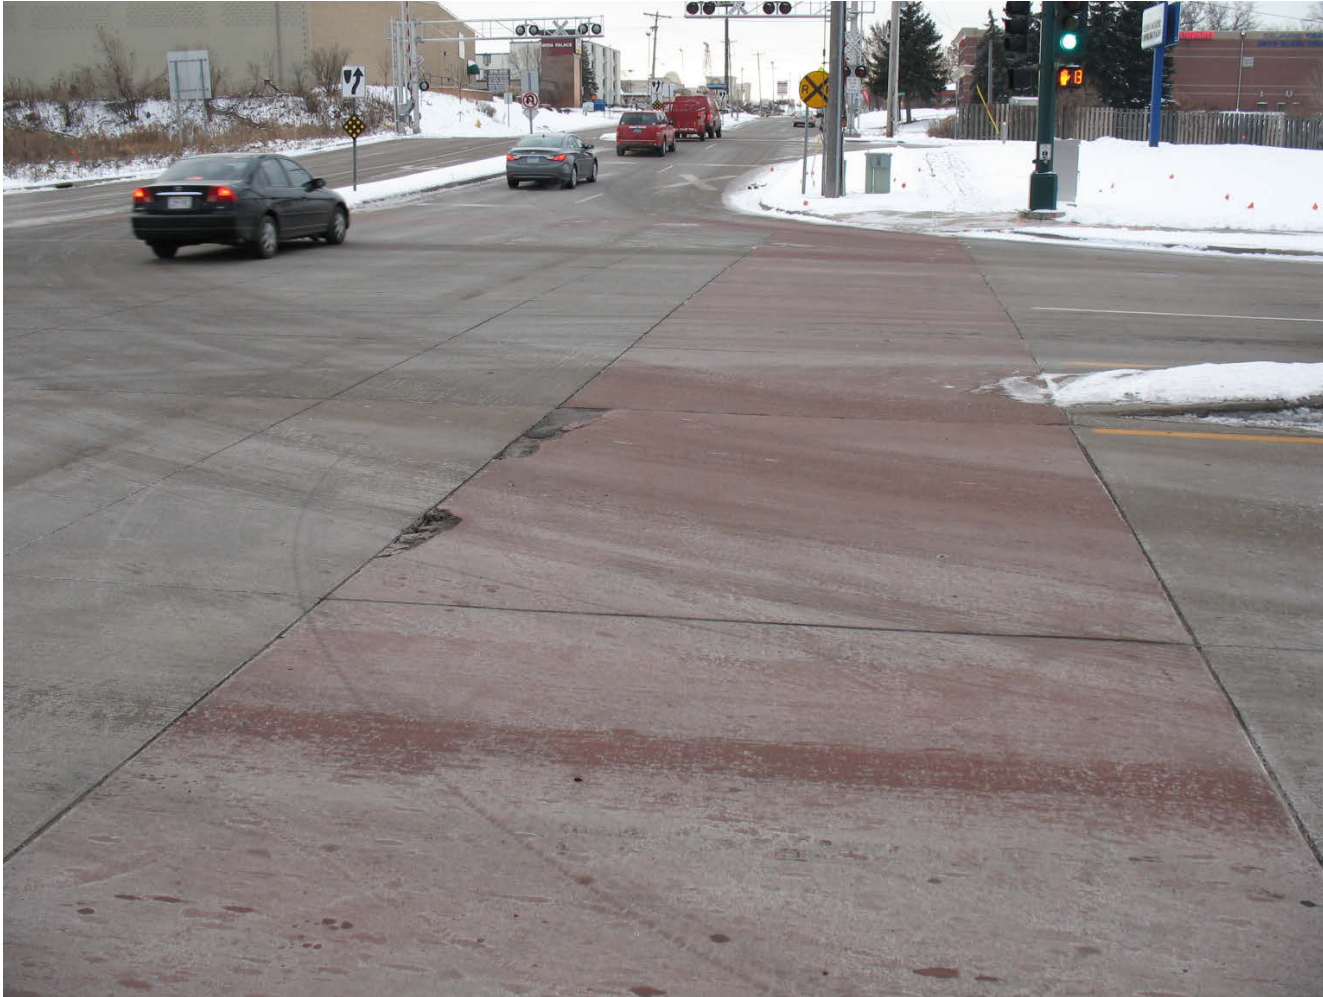
Cty Rd C and Cleveland, Roseville (Built 2006)

Good Performance

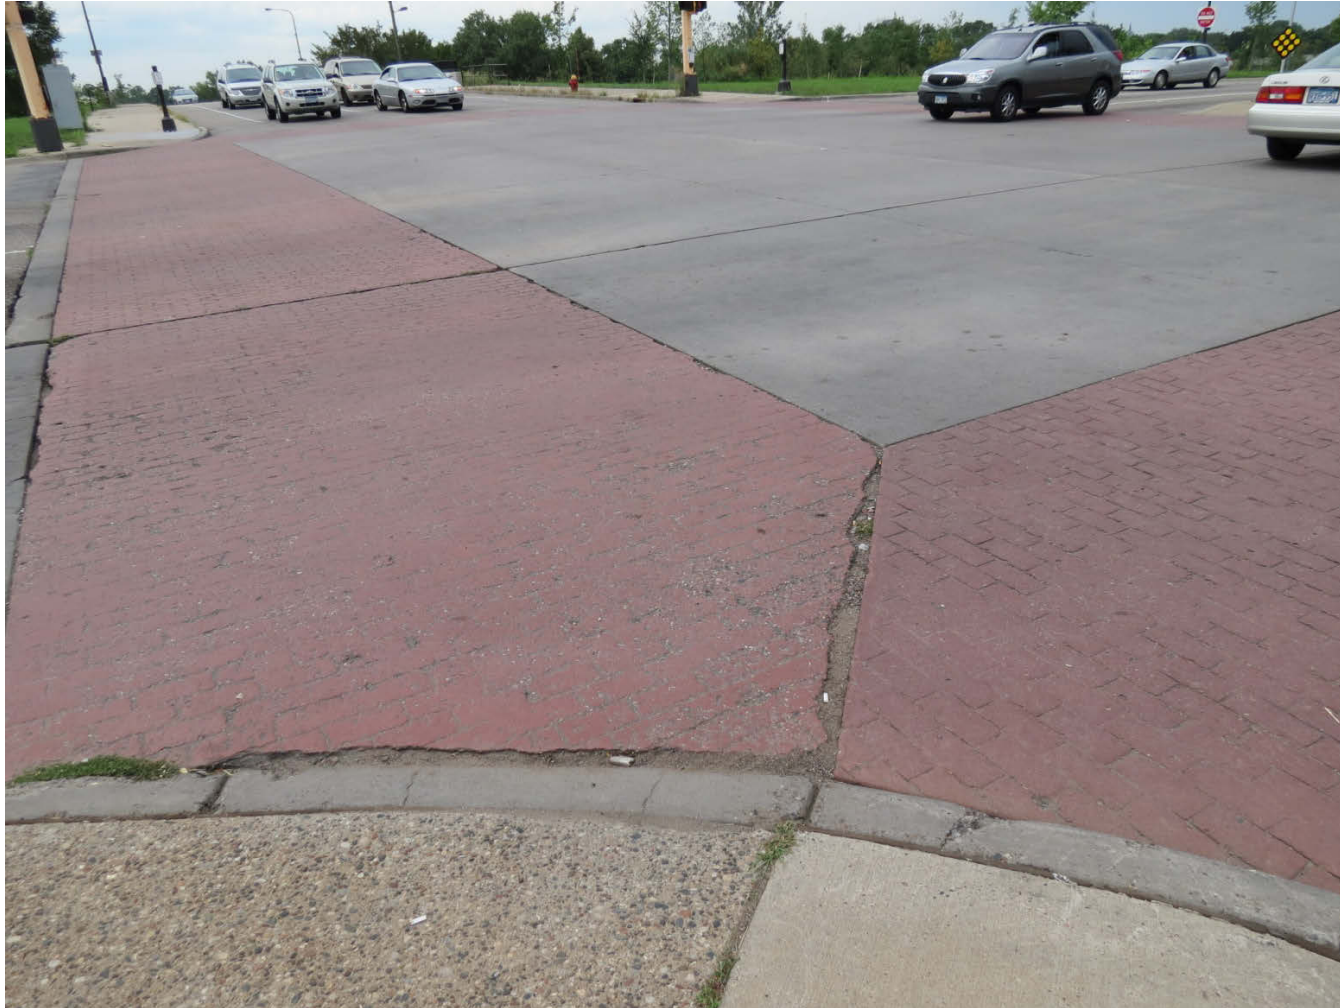
Phalen Blvd and Payne Ave, St. Paul (Built ?)

Fair Performance

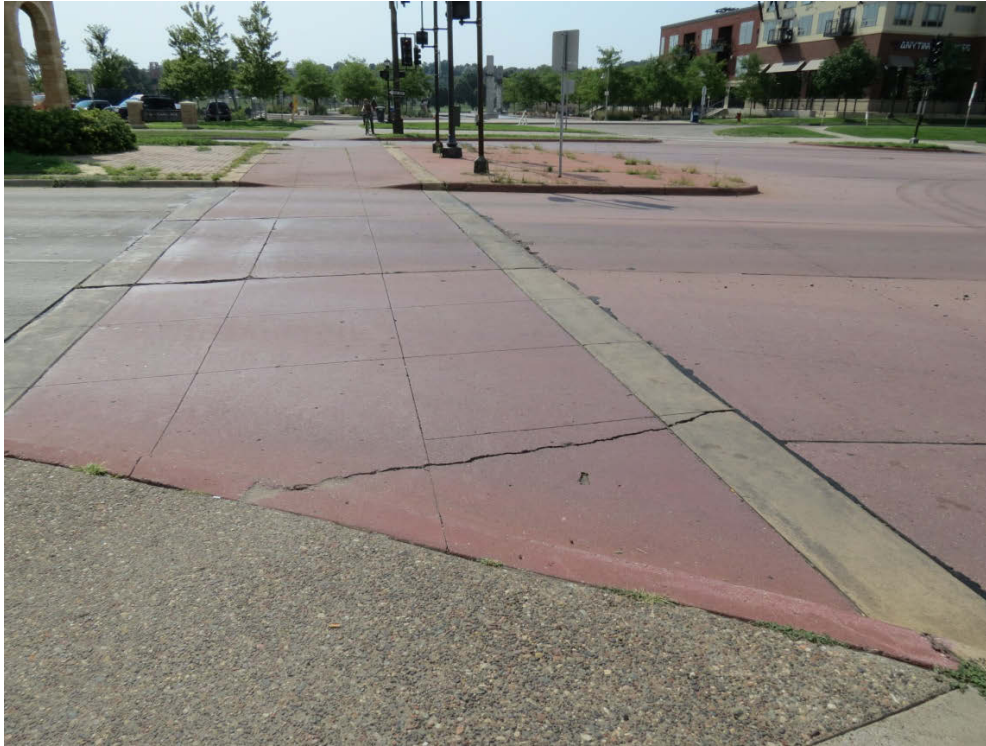
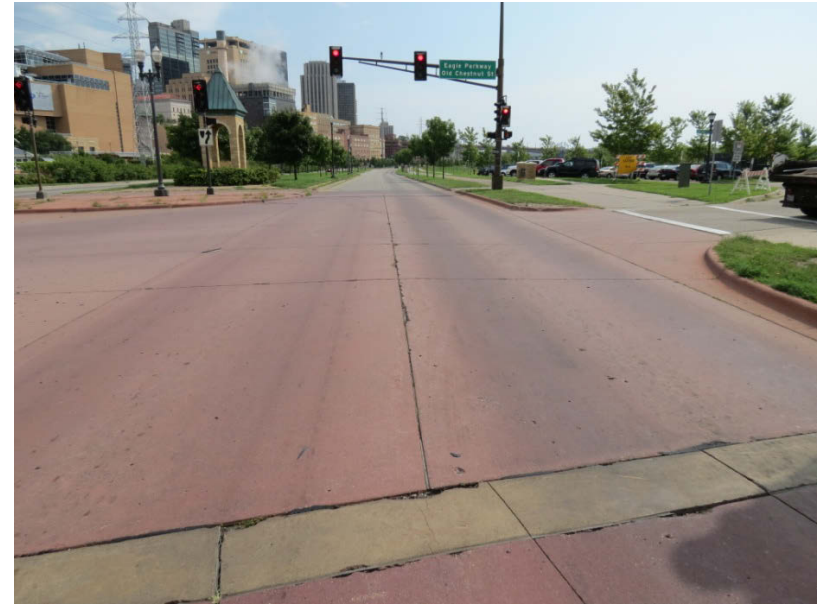
Shepard Rd and Old Chestnut St., St. Paul (Built ?)

Fair Performance

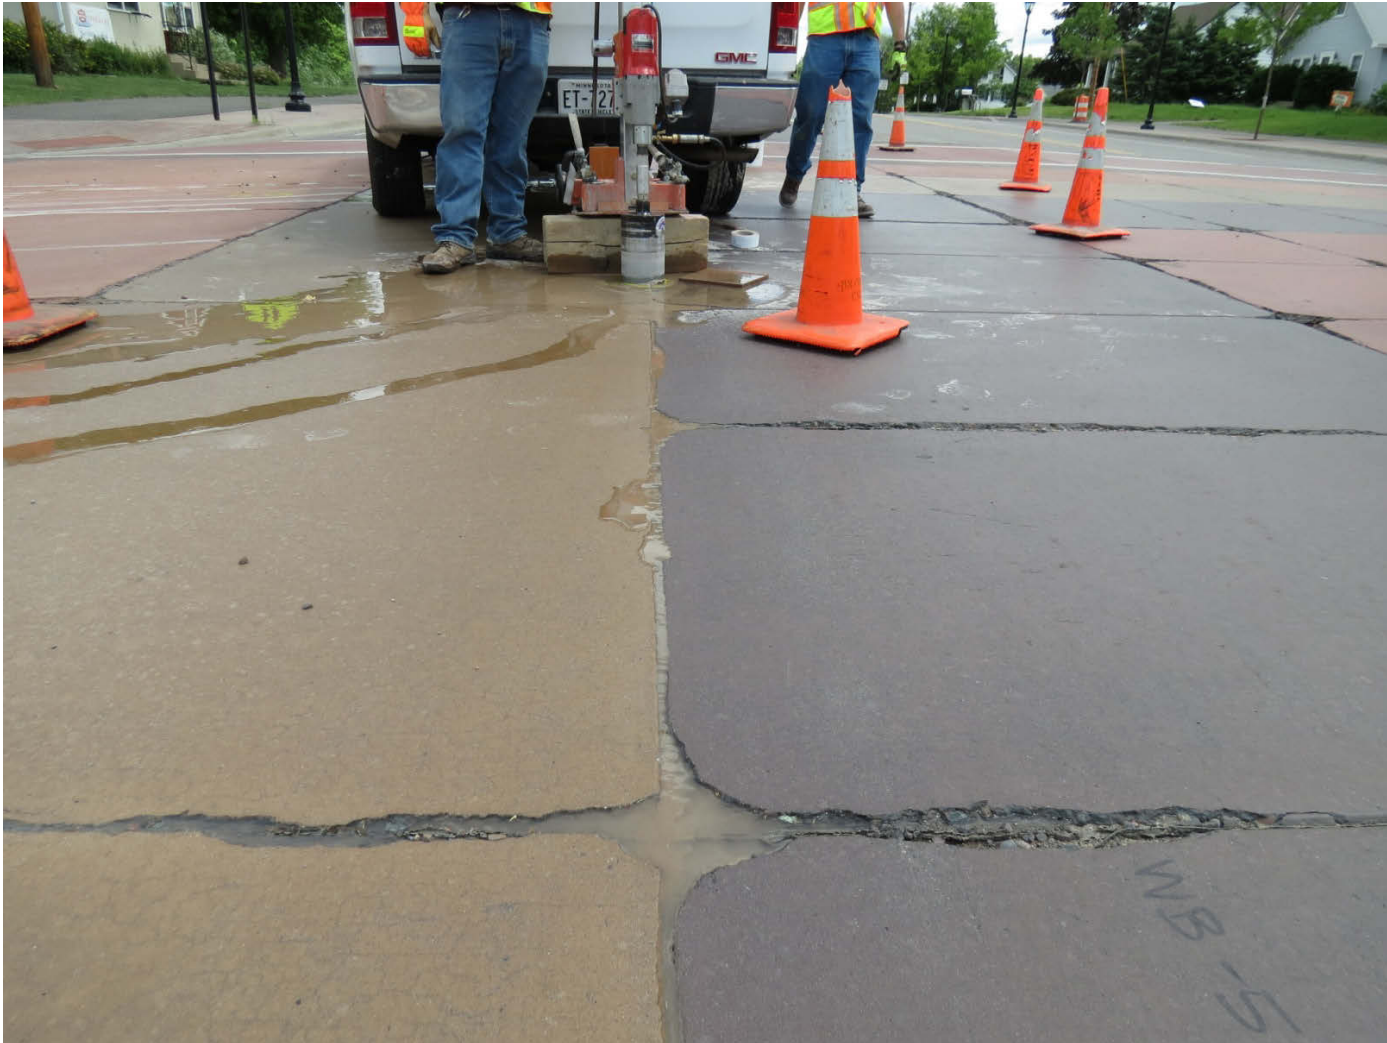
Cty Hwy 14, Main Street, Centerville

Constructed 2008

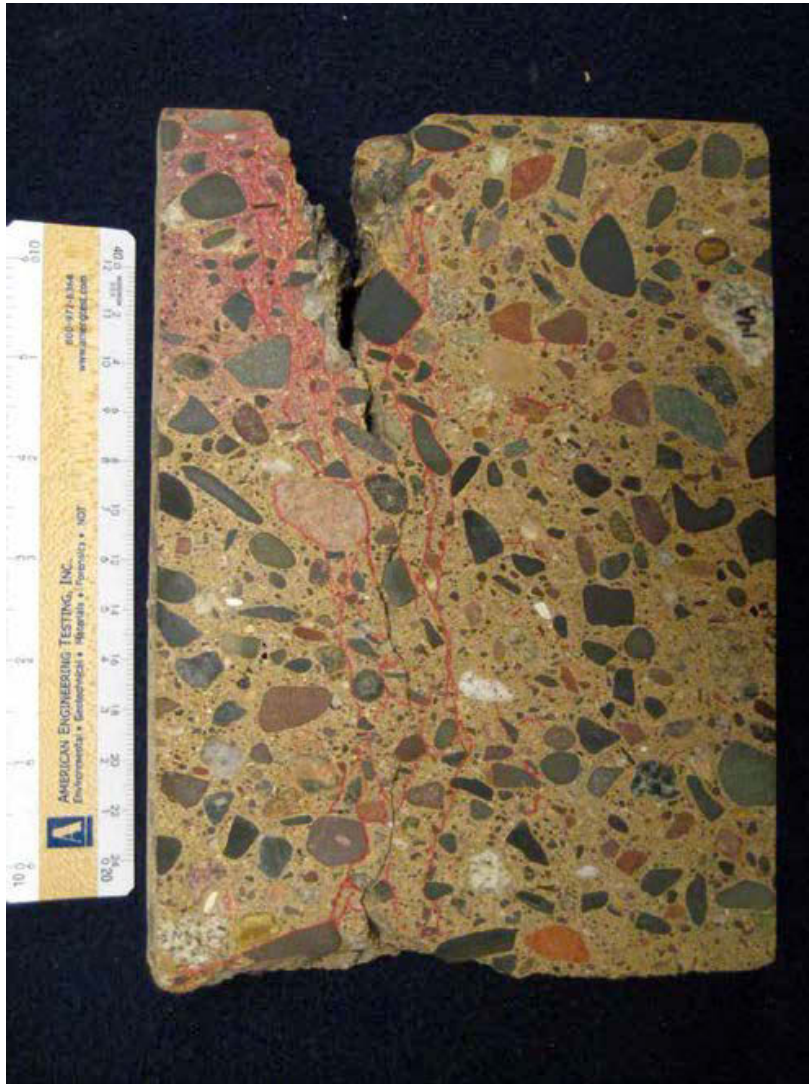
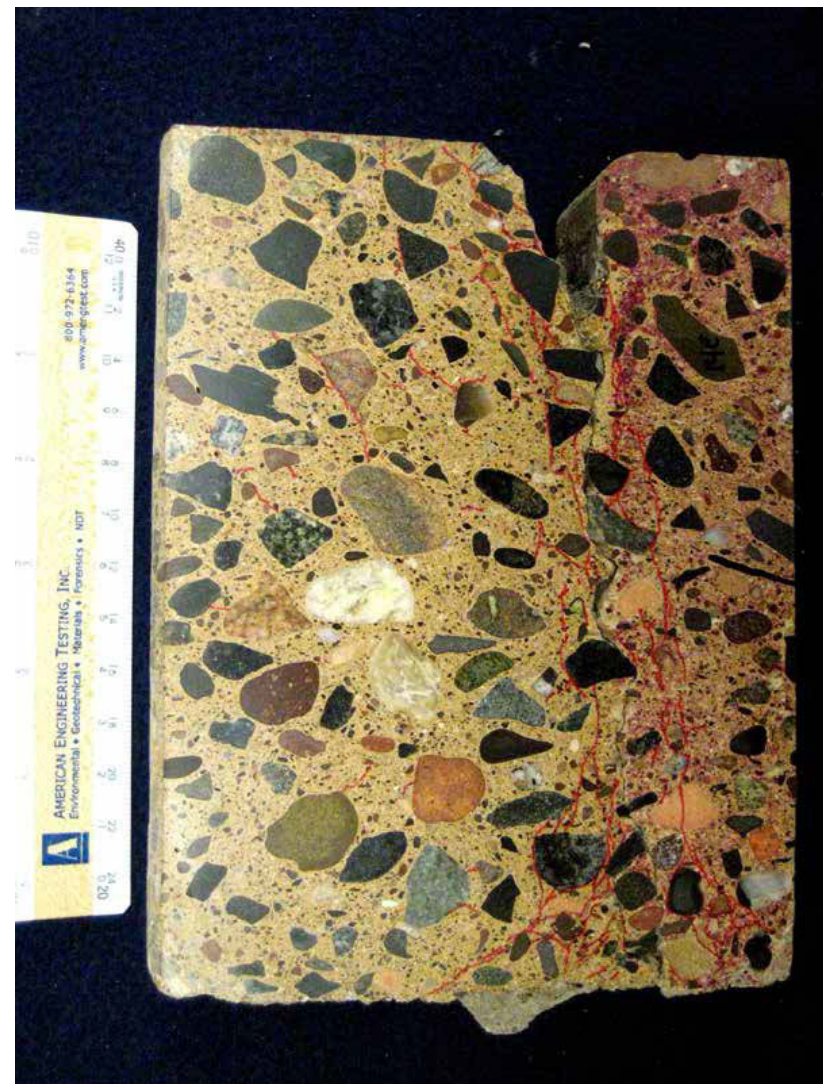
Cty Hwy 14, Main Street, Centerville

- Ø Concentrated micro-cracking through the depth of the joints
- Ø A poor bond between paste and aggregate
- Ø High water to cement ratios (up to 0.50)
 - Paste has high porosity
- Ø Initially adequate hardened air content system
 - System now filled with secondary ettringite near joints, significantly reducing freeze/thaw resistance
- Ø Surprising presence of ASR in aggregates typically used for concrete in Minnesota
- Ø Chemical alteration of paste
 - Possible chemical attack

- Ø Design colored concrete mixes with low water to cement ratios (maximum= 0.40)
- Ø Consider the effect certain deicers may have on increased saturation times in concrete joints
- Ø Improve curing methods
- Ø Provide good draining bases below concrete pavements
- Ø Seal your joints and edges
- Ø Improve safety of crosswalks and intersections with increased surface textures

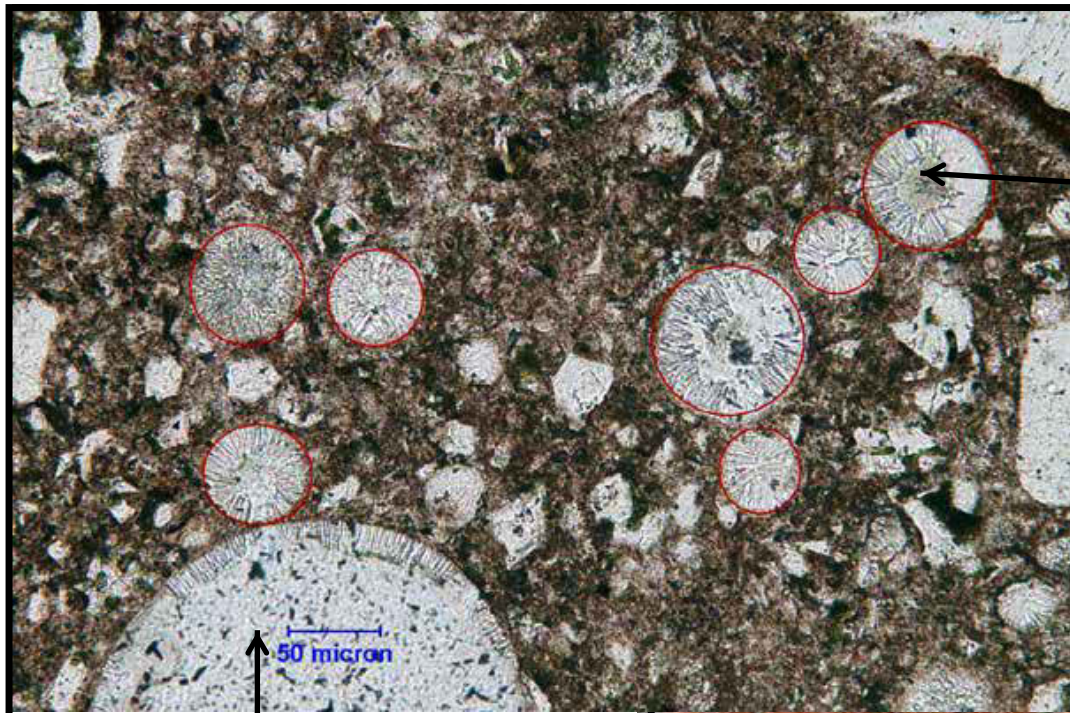
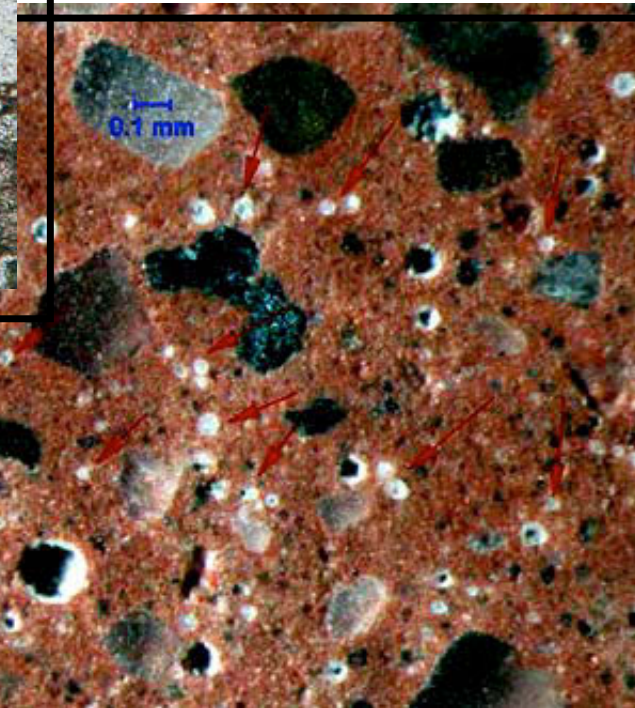
Secondary Ettringite

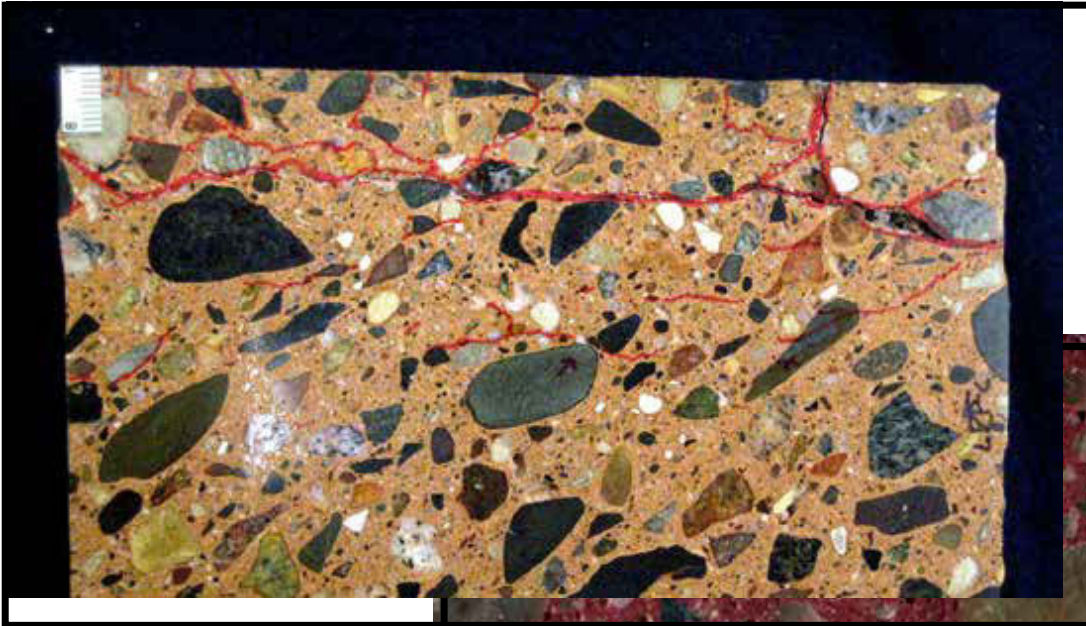
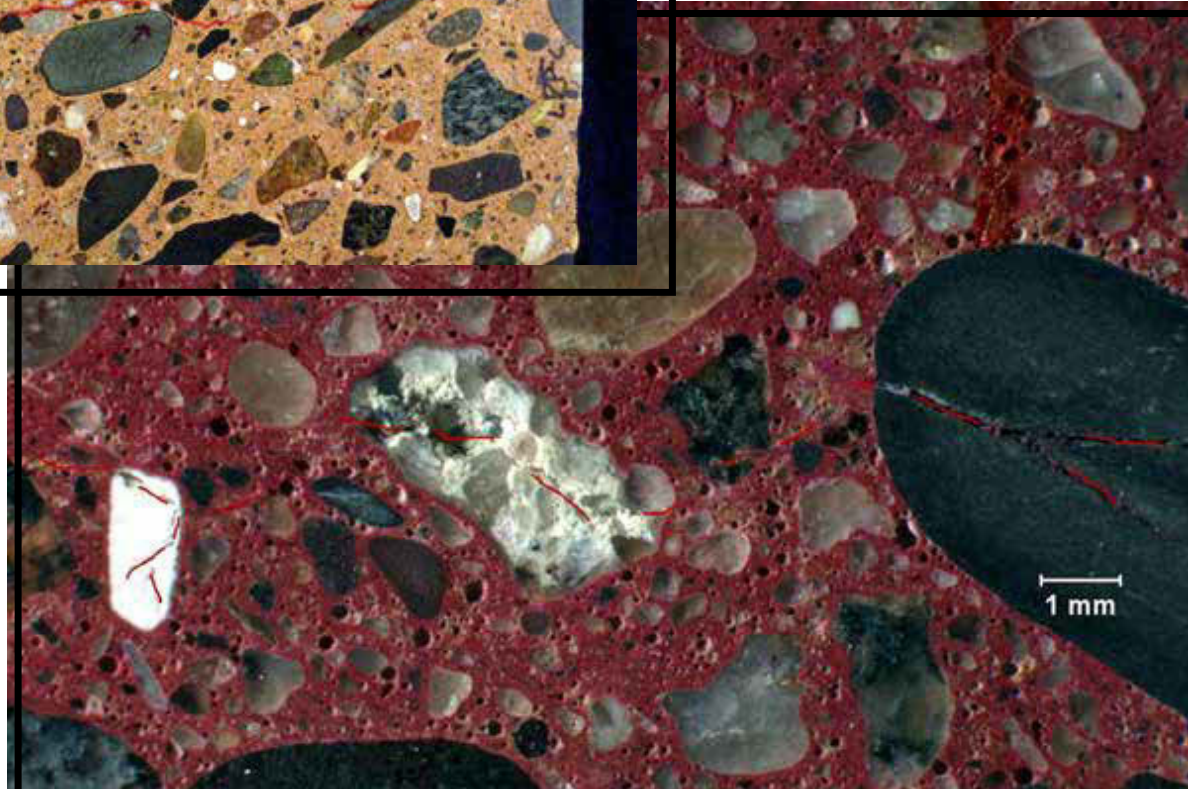
Alkali Silica Reaction

- Ø Does not appear that recent placement and finishing techniques are the direct cause of the early distresses observed
- Ø Most mixes appear to have too high a water to cement ratio for pavements located in Minnesota's extreme climate
- Ø Presence of ASR is a concern, as behavior is occurring away from joints as well
- Ø Cause of "chemical attack" needs to be investigated
